PROJECT SUMMARY REPORT FOR ASBESTOS RESPONSE ACTION
FLOOR TILE
GREENLEAF ELEMENTARY SCHOOL, ROOM 202
58 CHADWICK STREET, HAVERHILL, MA 01835

AXIOM PROJECT NUMBER 01288.006

SEPTEMBER 21, 2017

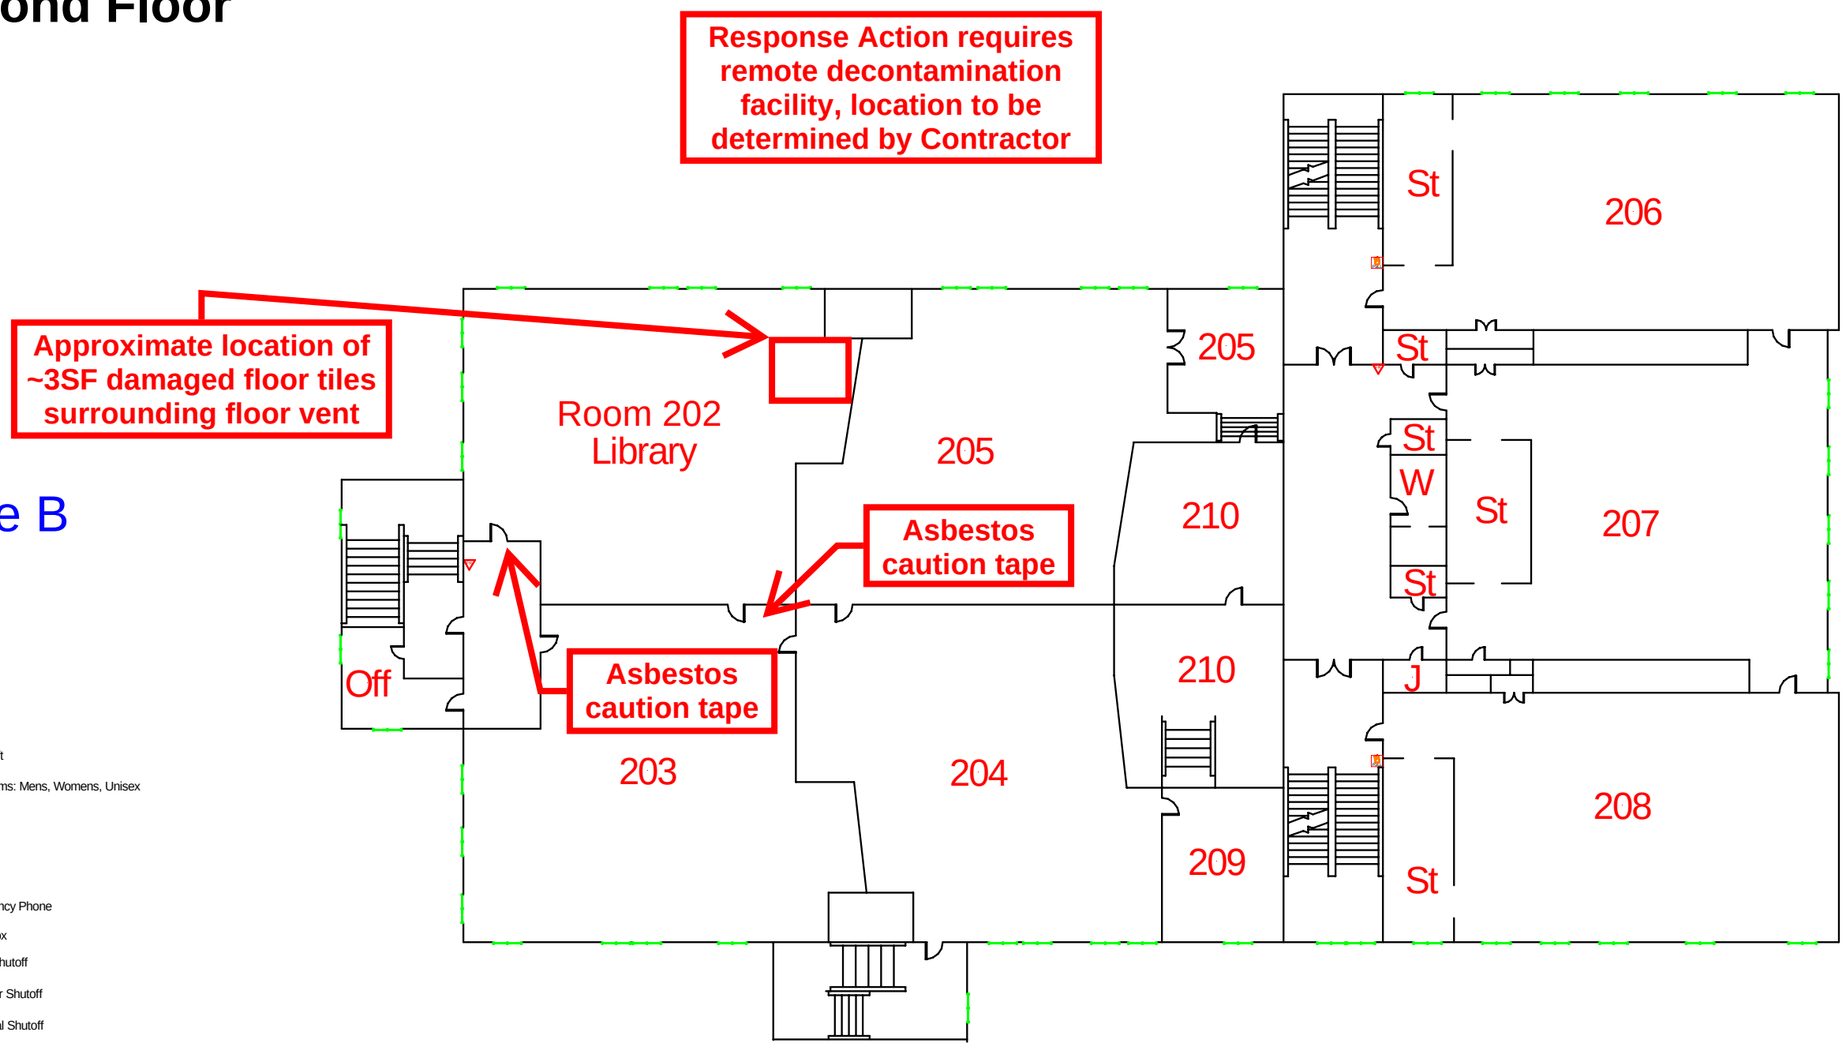
SITE DRAWING

The work involves the removal of a small damaged area (approximately 3 square feet) of asbestos-containing floor tile from Room 202 as identified on the attached site plan. The damaged tile must be removed before contractors can cover the floor with wall-to-wall carpeting.
